New York State Department of Transportation

Yellow Flag NB22U4W002

BIN: 1065318

Feature Carried: 278I278IX2M23027

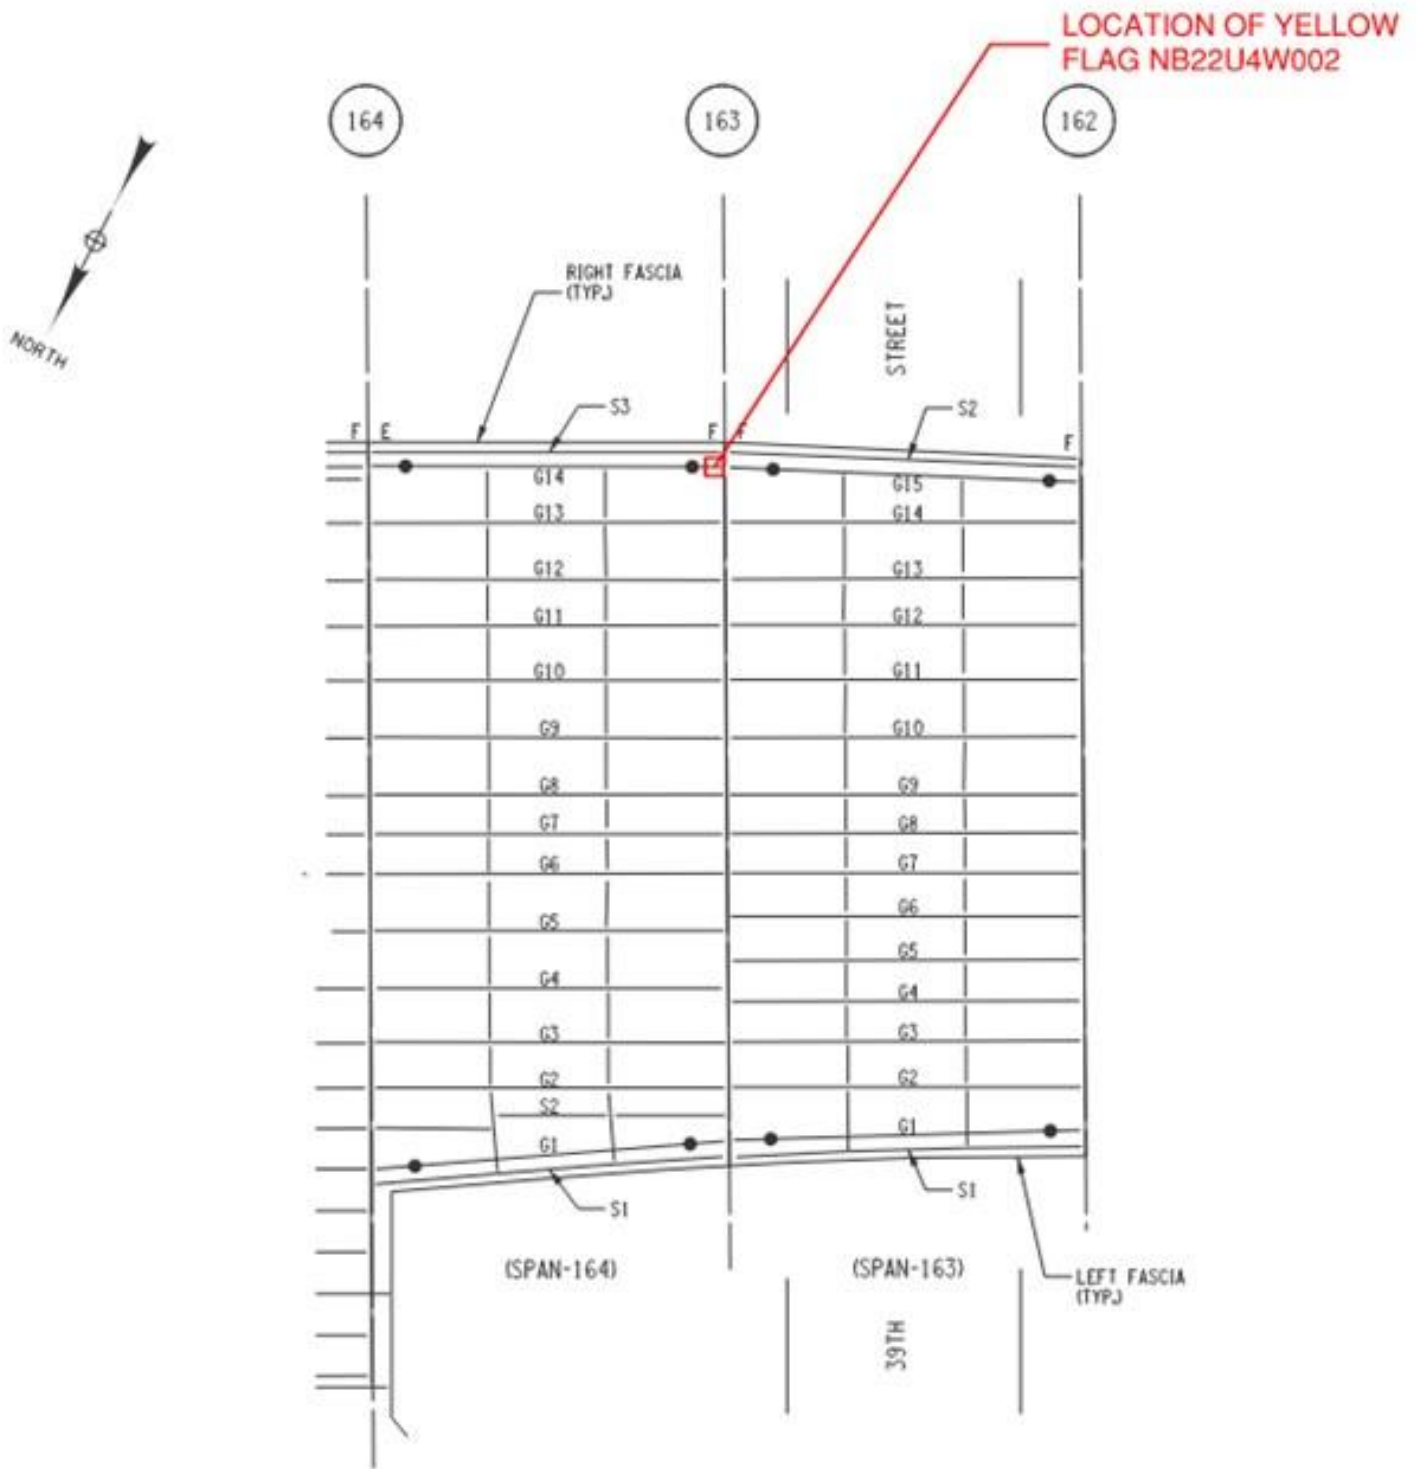
Photo Number: 1

Location: Span 164, Girder G14 at Pier 163 located within scaffolding platforms installed by contractor which is located above parking lot between 38th and 39th Street.

**Attachment Description: YELLOW FLAG LOCATION PLAN**

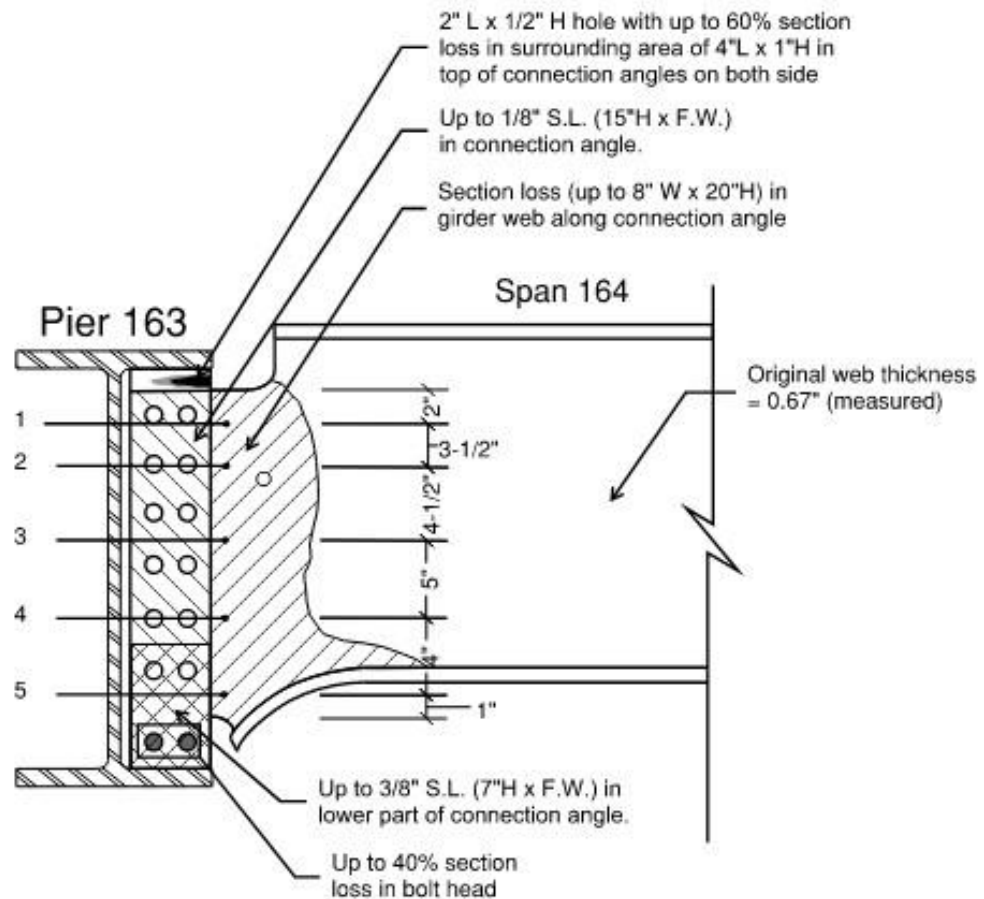
Photo Number: 2

The Girder G14 end at Pier 163 exhibits severe section loss with 0.21" – 0.36" remaining thickness measured (RTM) in the web shear area along the connection angle resulting in approximately 56% section loss. (Sketch 1, Photos 7 & 8).

Refer to Yellow Flag Condition Sketch 1, Photo #2 for more details.

SPAN 164, GIRDER G14 BEAM END
(LOOKING LEFT)
N.T.S

LOCATION	RTM (in.)
1	0.28
2	0.33
3	0.27
4	0.36
5	0.21

TRIBUTARY LENGTH CALC. FOR SHEAR AREA			
	ABOVE (in.)	BELOW (in.)	TOTAL (in.)
FOR POINT 1	2	1.75	3.75
FOR POINT 2	1.75	2.25	4
FOR POINT 3	2.25	2.5	4.75
FOR POINT 4	2.5	2	4.5
FOR POINT 5	2	1	3

Section Loss Calculations:

Original girder web thickness = 0.67" (measured)

Shear web area = $(0.28" \times 3.75") + (0.33" \times 4") + (0.27" \times 4.75") + (0.36" \times 4.5") + (0.21" \times 3") = 5.90 \text{ in}^2$

Overall shear web area section = $[(0.67" \times 20") - 5.90 \text{ in}^2] / (0.67" \times 20") \times 100\% = 56\% \text{ section loss}$

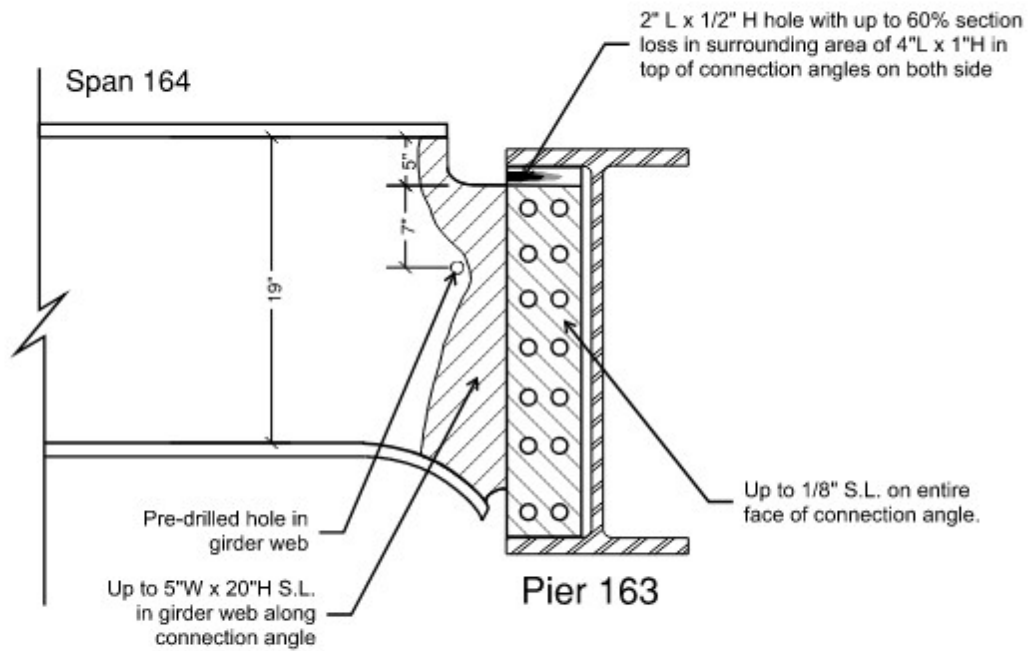
Photo Number: 3

Additionally, the connection angle on the right side of the girder exhibits up to 1/8" section loss x full width for 15" from top and 3/8" section loss x full width for remaining height of the connection angle. There is a 2" L x 1/2" H hole with up to 60% section loss in the surrounding 4" L x 1"H area in top of the connection angle. 2 bolts in the lower part of the right connection angle exhibit up to 40% section loss in the bolt head. The connection angle on the left side of the girder exhibits up to 1/8" section loss on entire face of connecting leg.

SPAN 164, GIRDER G14 BEAM END
(LOOKING RIGHT)
N.T.S

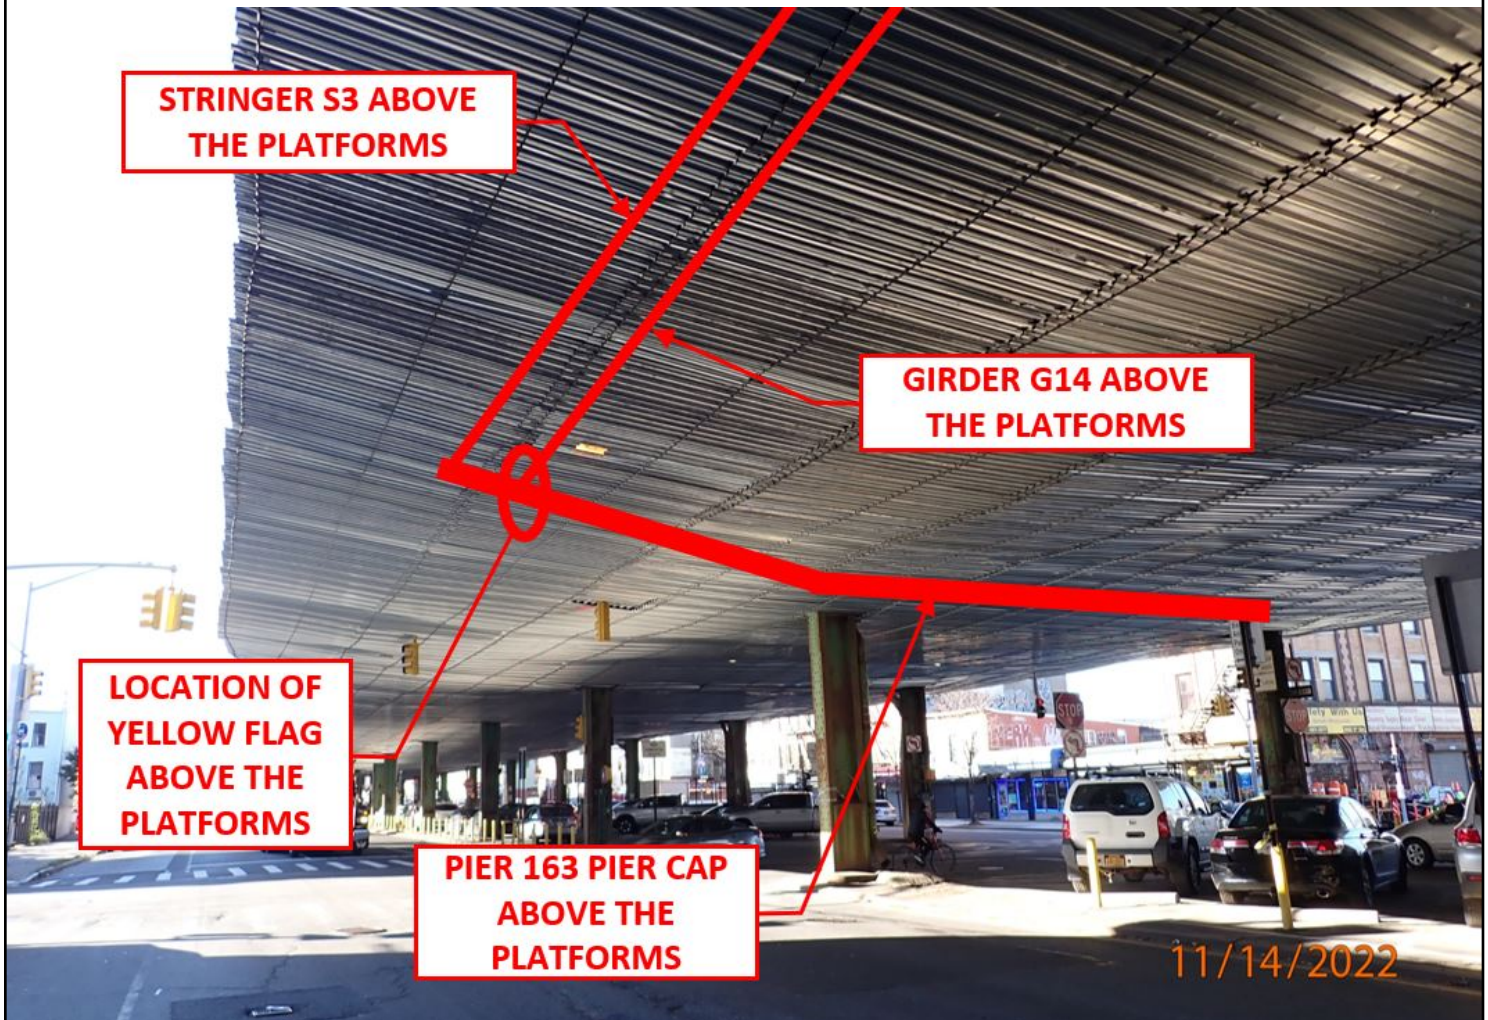
Photo Number: 4

Attachment Description: General view of flagged condition at Girder G14 in Span 164 at Pier 163 (located above the installed shielding platform). Looking Begin - Left

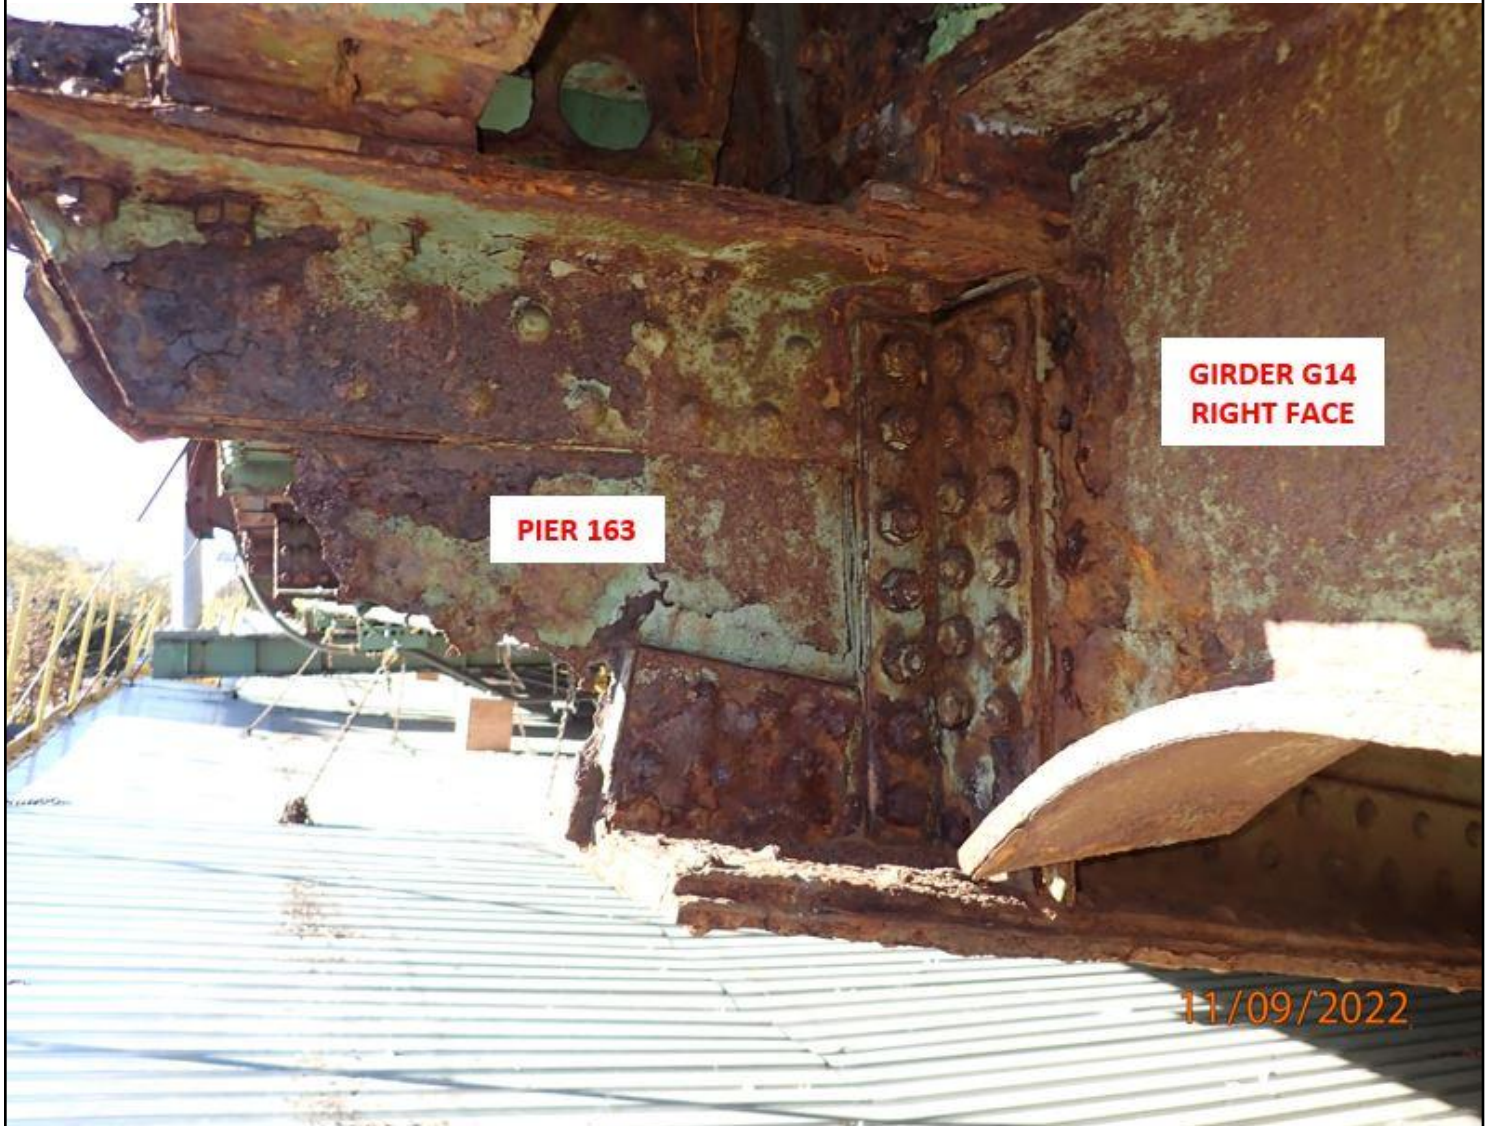
Photo Number: 5

Attachment Description: General view of Girder G14 in Span 164 at Pier 163. Looking Begin and Left.

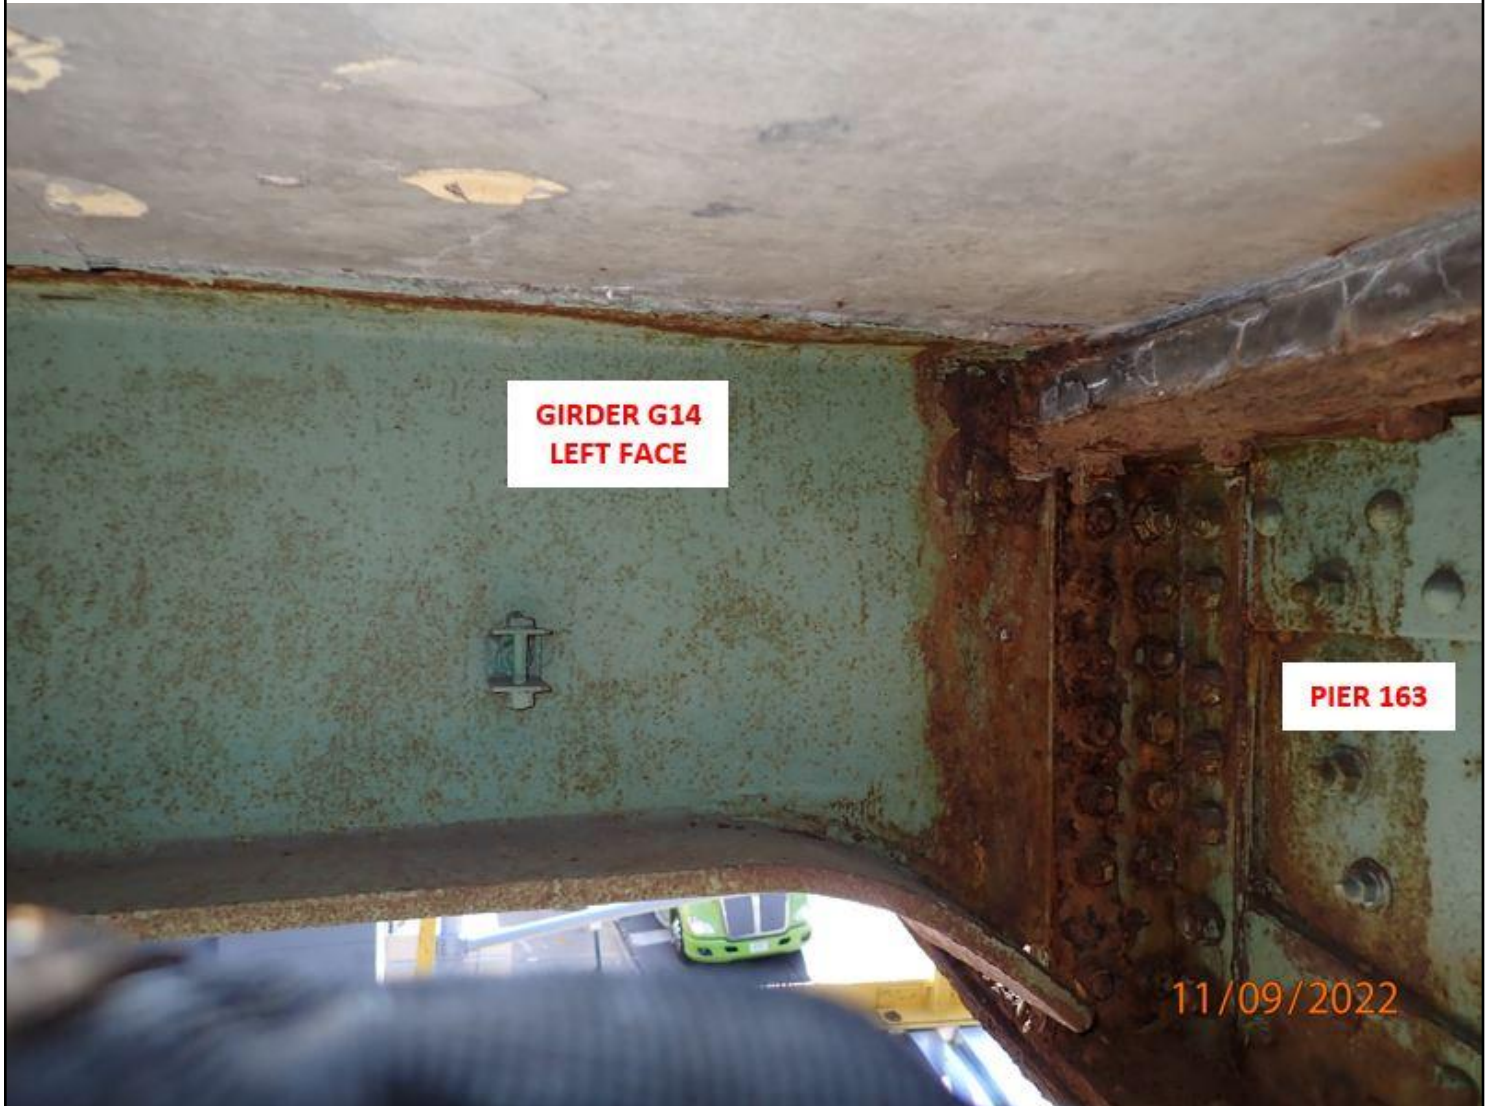
Photo Number: 6

Attachment Description: General view of Girder G14 in Span 164 at Pier 163. Looking Right.

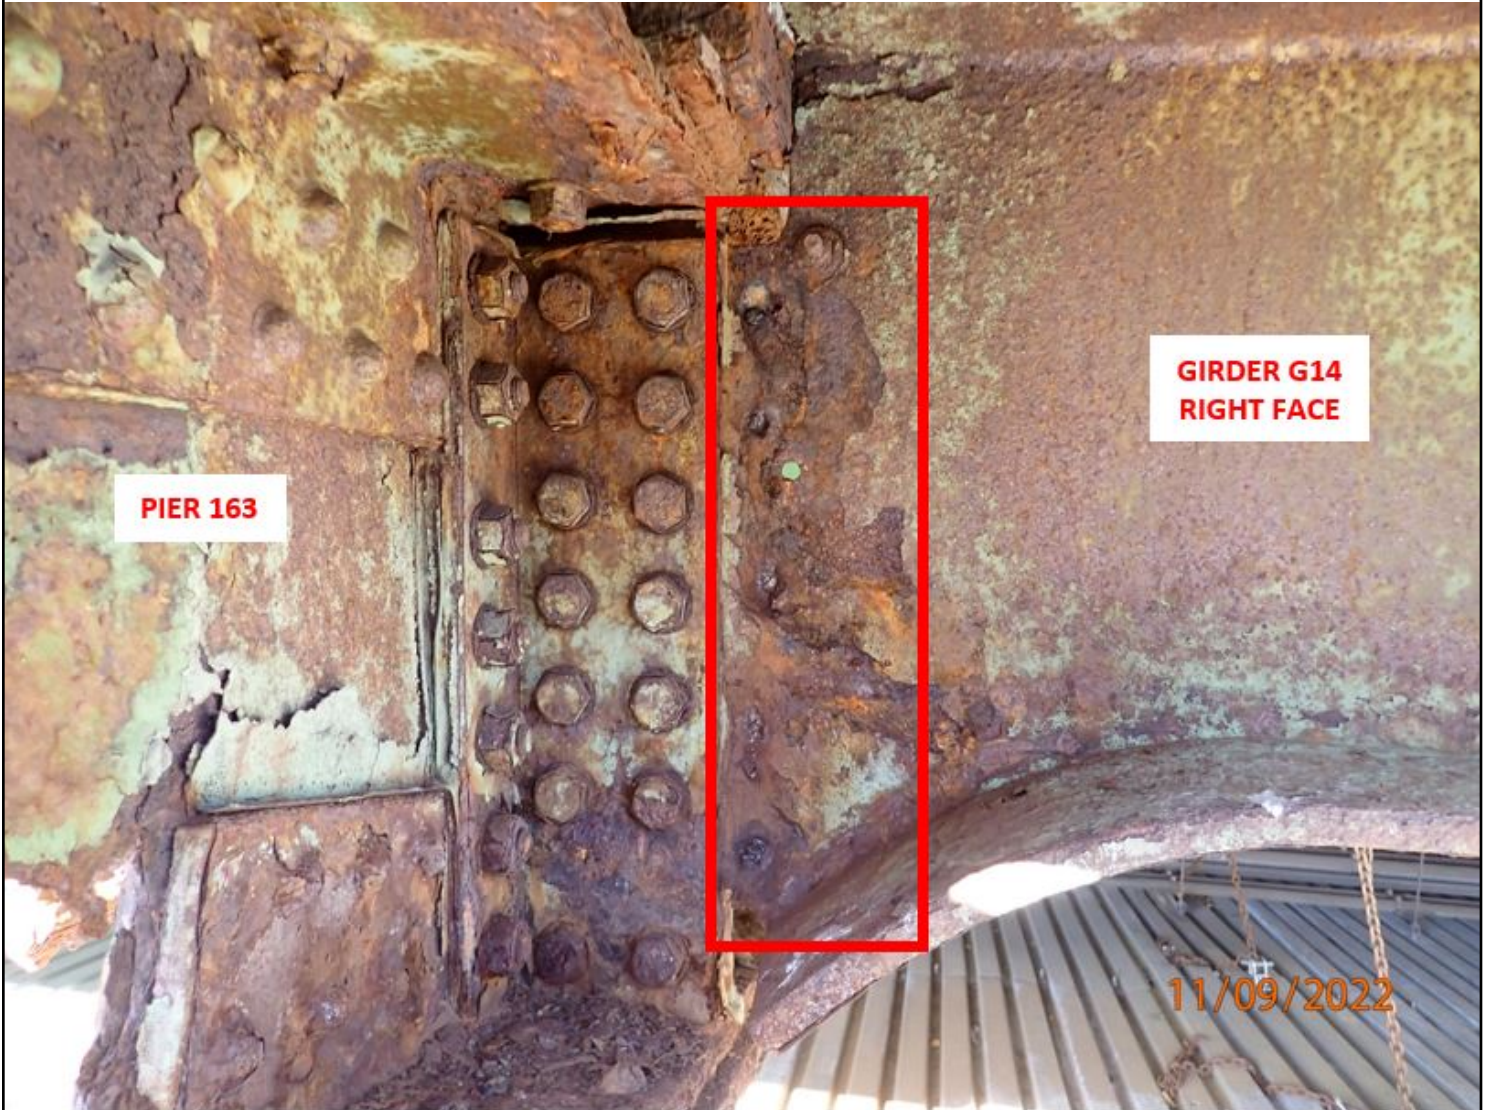
Photo Number: 7

Attachment Description: Right face of Girder G14 in Span 164 at Pier 163. The end of Girder G14 web exhibits severe section loss (approximately 56% section loss) along the connection angle. Additionally, the connection angle exhibits up 3/8" S.L. x F.W. with a 2" L x 1/2" H hole in top of the connection angle. 2 bolts at the base of connection angle exhibit up to 40% section loss in the bolt head. Looking Left

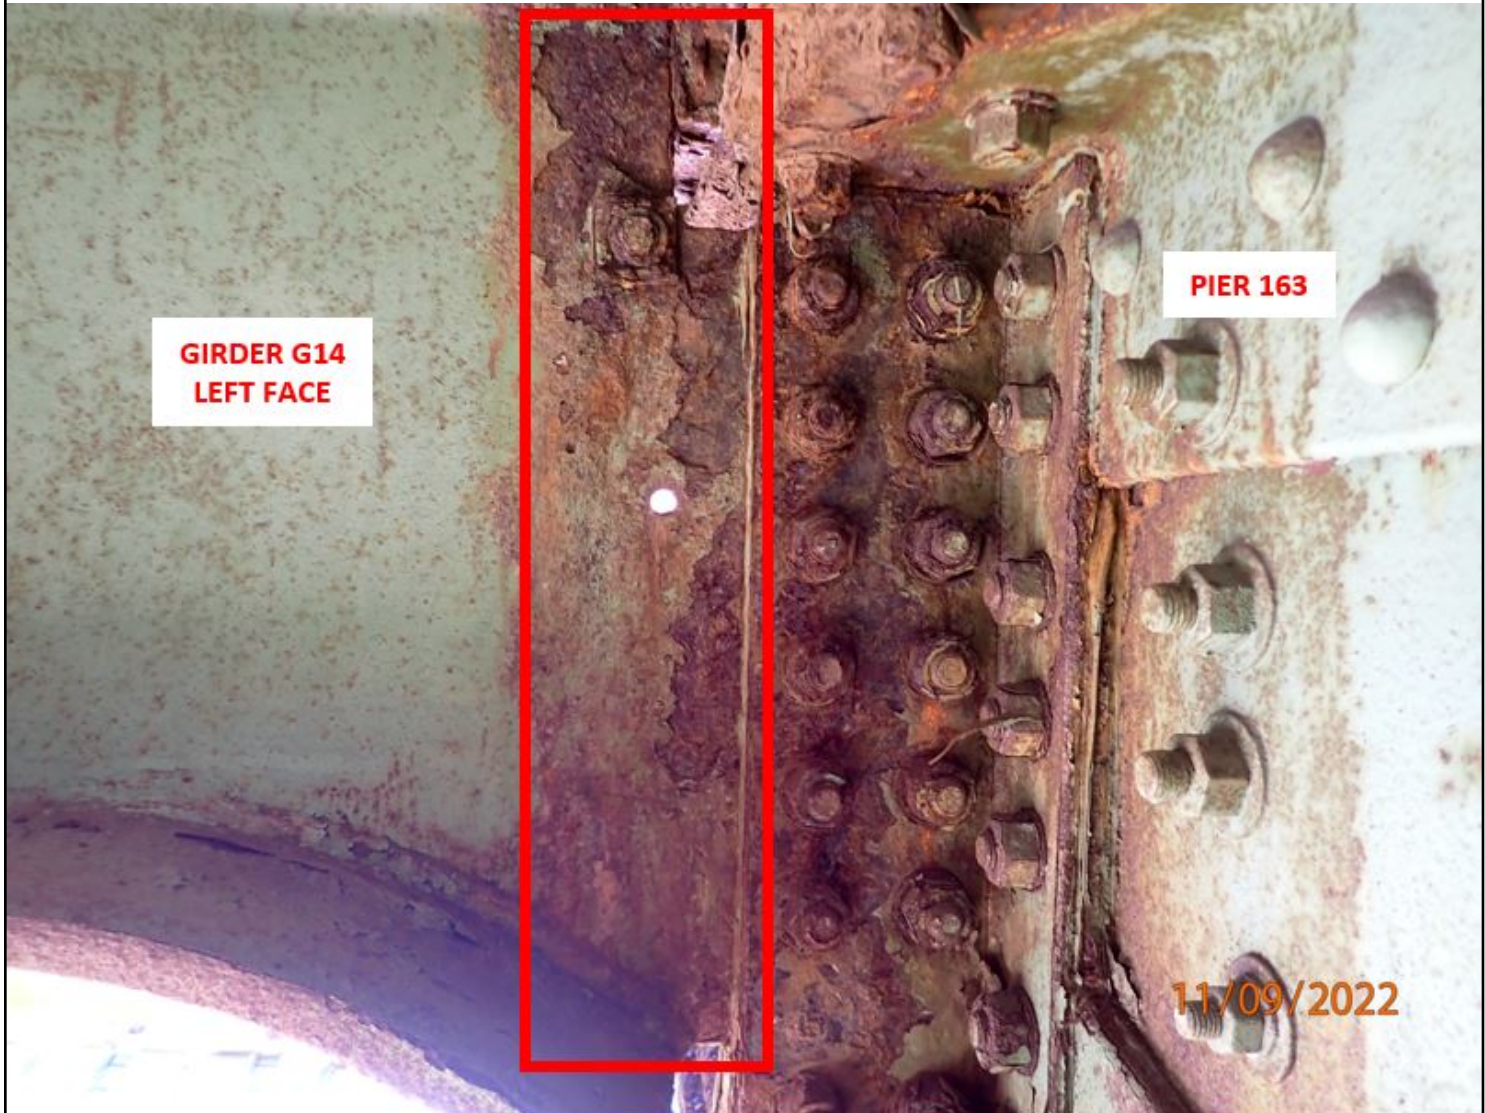
Photo Number: 8

Attachment Description: Close-up view of left face of Girder G14 in Span 164 at Pier 163. The end of Girder G14 web exhibits severe section loss (approximately 56% section loss) along the connection angle. Additionally, the connection angle exhibits up 1/8" S.L. x F.W. with a 2" L x 1/2" H hole in top of the connection angle. Looking right.
